## **【LUXON AGILE】 About the axial stroke width of the rotor shaft**

~In order to maintain motor performance, we will release a replacement AGILE dedicated pipe type SHIM.~

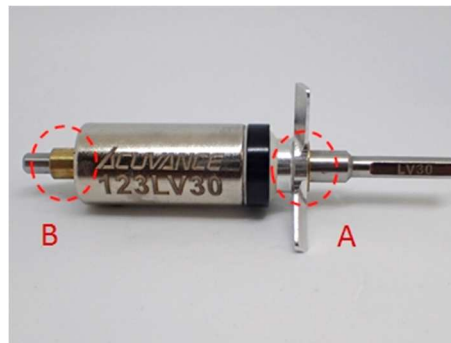
LUXON AGILE adjusts the axial stroke width by fitting a washer type SHIM (A in the figure below) on the pinion gear side of the rotor shaft and a pipe type SHIM (B in the figure below) on the end bell side.

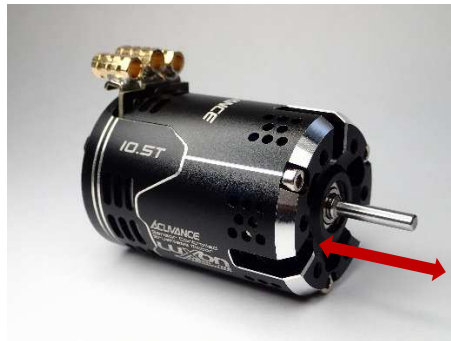
The axial stroke width is very important from the viewpoint of running performance and motor protection, and even a slight individual difference level of a few commas in the rotor manufacturing process has an effect.

It's important to have a stroke width of about 0.3 to 0.5mm in the axial direction of the shaft

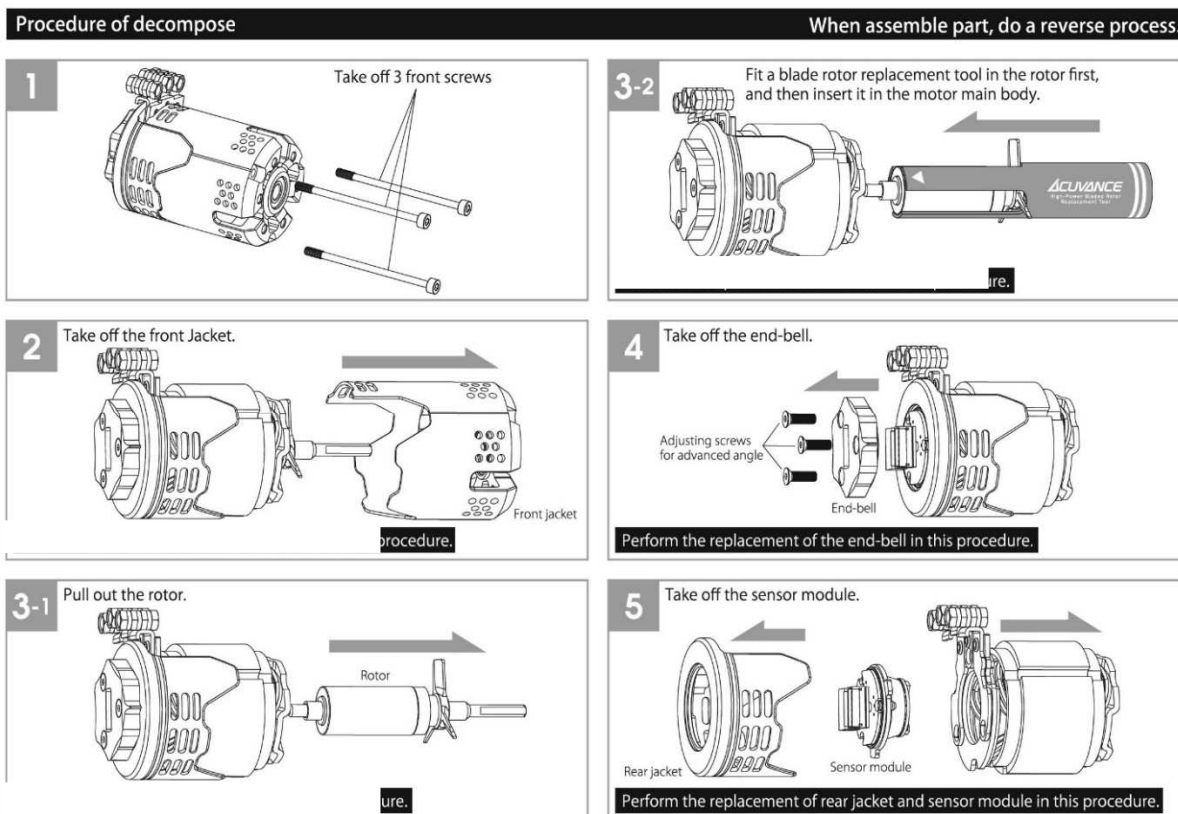
If the gear is worn down and the pinion gear and spur gear are not properly meshed (not vertical), or the front side SHIM is fitted with another motor SHIM, there is almost no stroke width. If excessive stress is applied in the direction of the end bell and the vehicle continues to run in this state, the pipe type SHIM (B) on the end bell side may wear out and wear out.

When the pipe type SHIM is worn down, the rotor stroke width becomes extremely large, causing problems such as "the rotor magnet part comes into contact with the sensor element" and "the sensor signal cannot be transmitted normally". Therefore, if you feel that the stroke of the rotor shaft has increased, we recommend replacing the pipe type SHIM (B).

When replacing the SHIM, it is necessary to disassemble the motor just as when replacing the rotor. Please follow the steps below. (SHIM replacement is performed in step 3-1 below)

\* As shown in 3-2, using our optional blade rotor replacement tool (OP-15056 / JPY2,000-) enables smooth replacement.
